## Project information

Channel lining

Squamish, BC

CC was used to redirect water and stop erosion

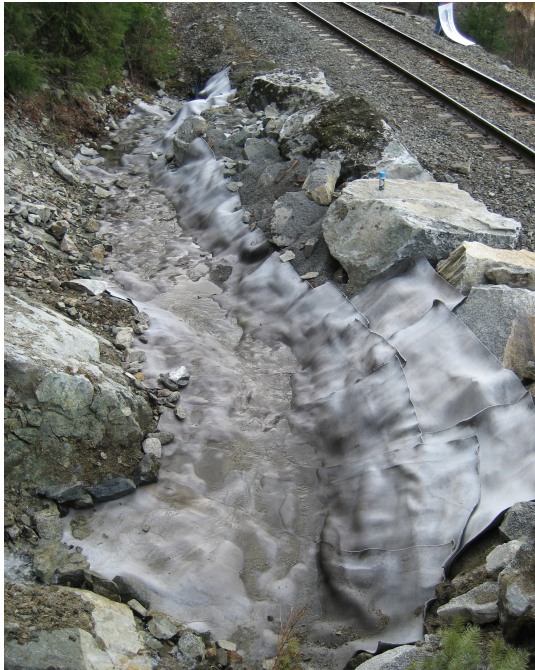
CC laid to direct water to culvert

It was unfeasible to remove the track to repair the rail bed. The railroad company needed a solution that would protect the rail bed from becoming compromised. The solution was to line the ditch to redirect water flow to a nearby culvert.

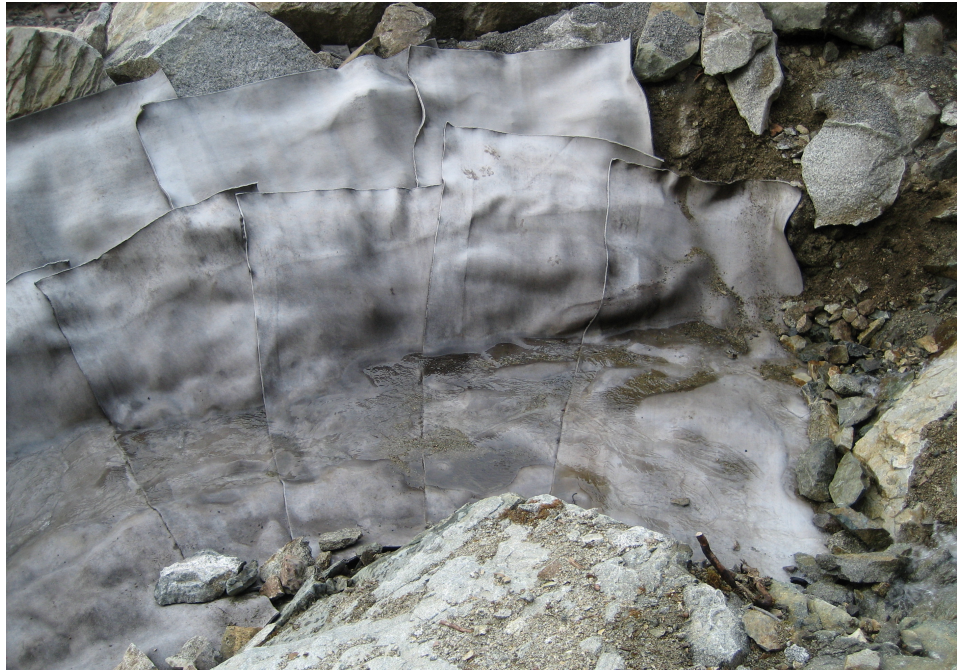
Extra layers of CC to protect track

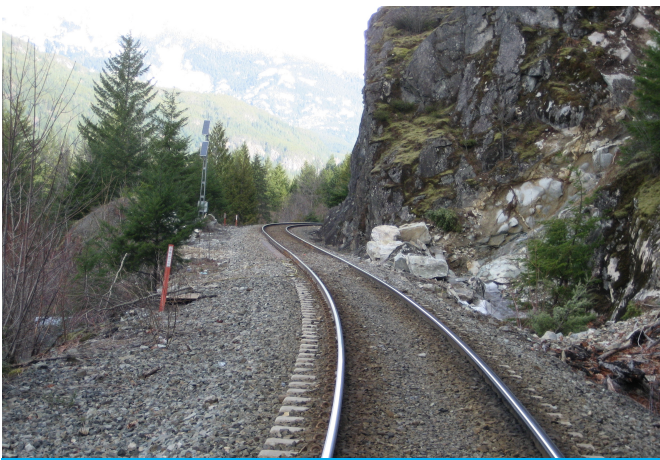
Site only accessible by rail

Workers used a rail cart to deliver the product to site and brought in an excavator by rail to unroll the bulk of CC.

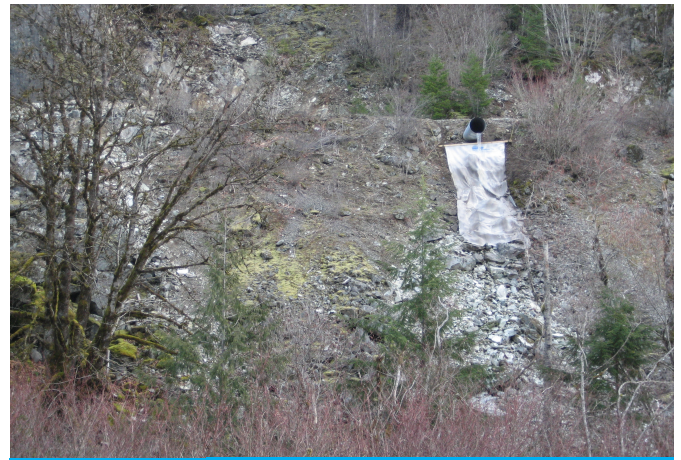
Custom CC drape for water overflow
